Memorandum Number MERL 2011-34

## **Evaluation of New Concrete Shrinkage Reducing Additive for Glen Elder Dam Spillway Inlet Slab Repair**

**Missouri River Basin Project –  
Solomon Division – Glen Elder Unit - Kansas  
Great Plains Region**

August 2011

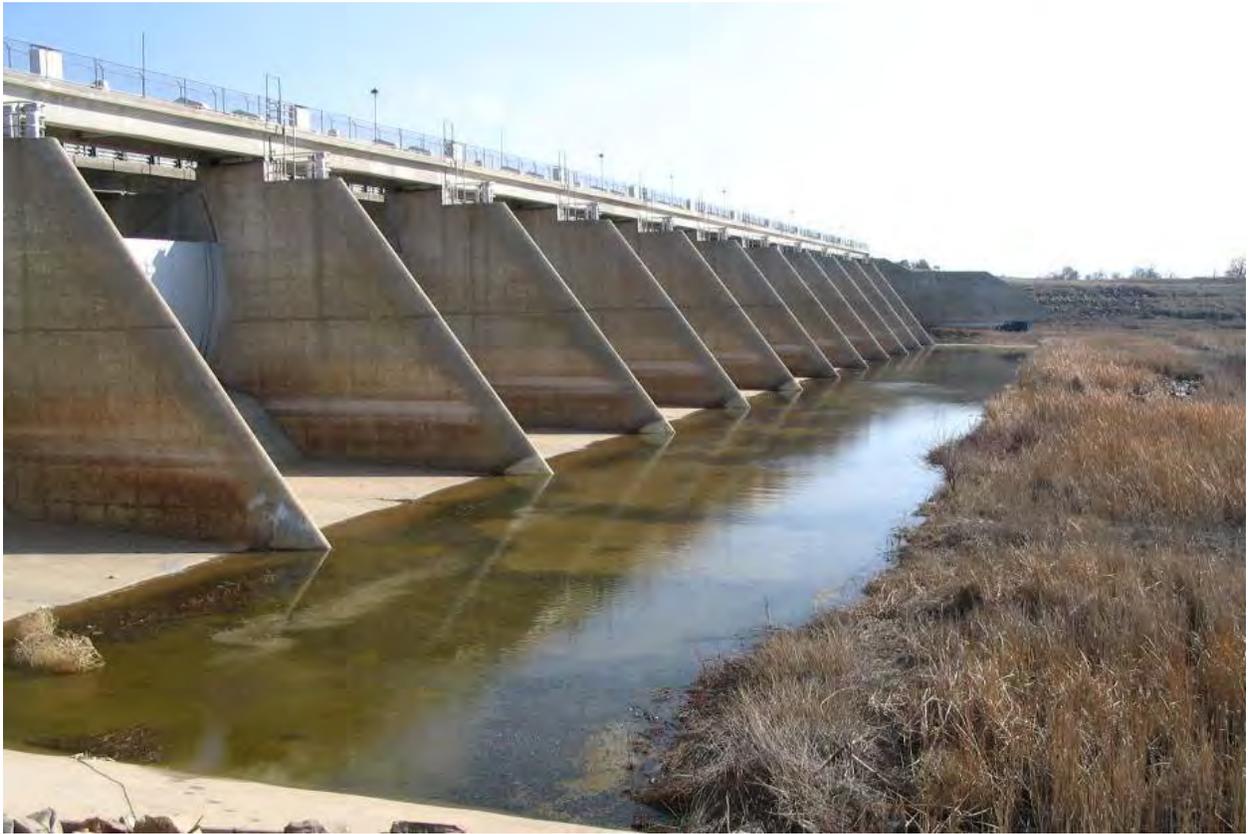
The invert of the excavated inlet channel upstream of the inlet apron is approximately 1 foot higher than the inlet apron invert which creates a grassy berm upstream of the spillway. As a result, water which is located on top of the inlet apron (either from receding reservoir levels or precipitation) becomes trapped and remains ponded in this area (Figure 2).

**Figure 2. – View of approach area of spillway. The soil berm trapped water on the apron, leading to deterioration of the concrete.**

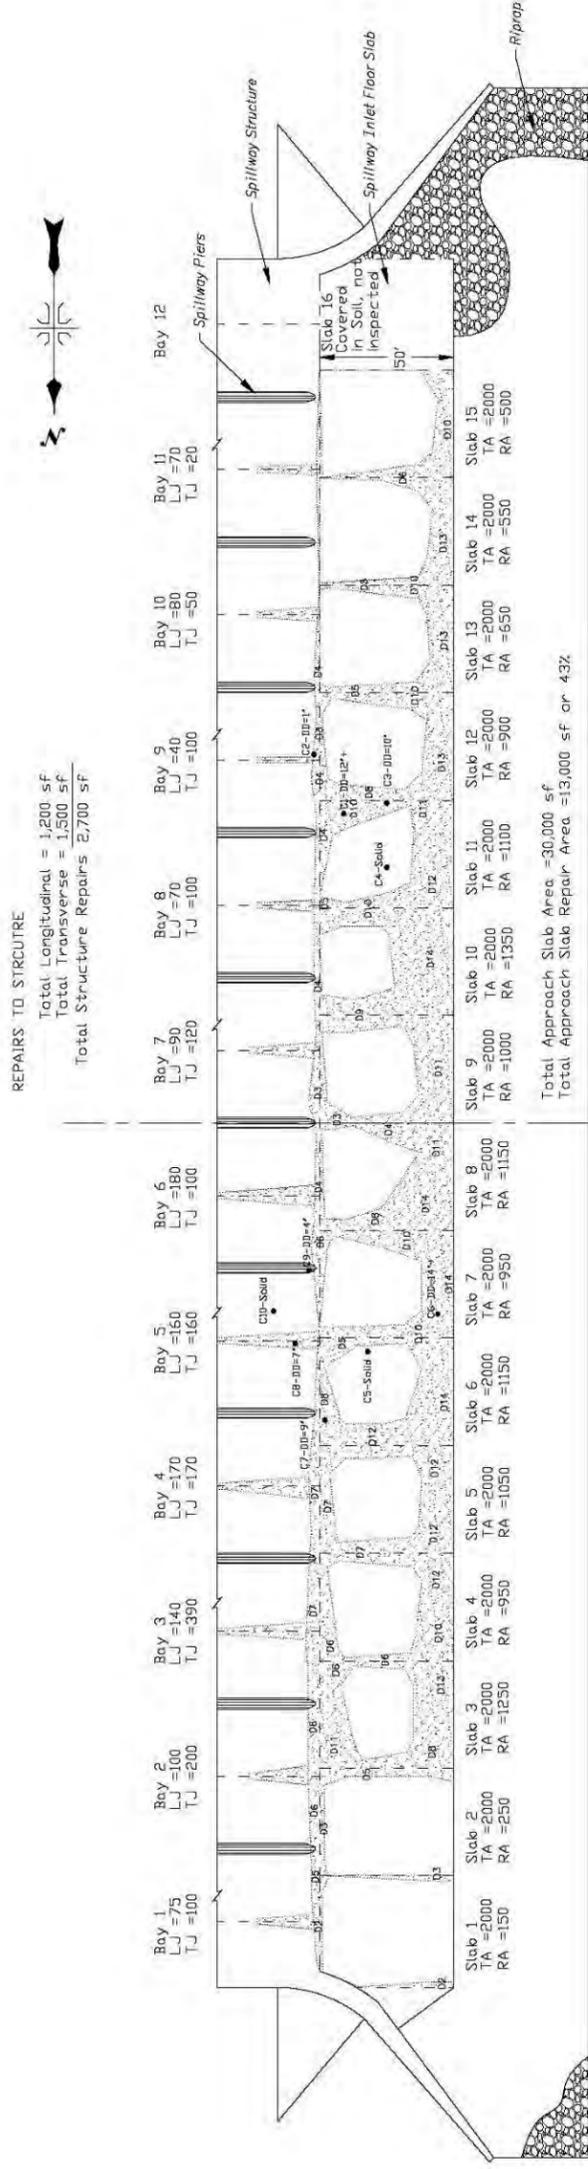
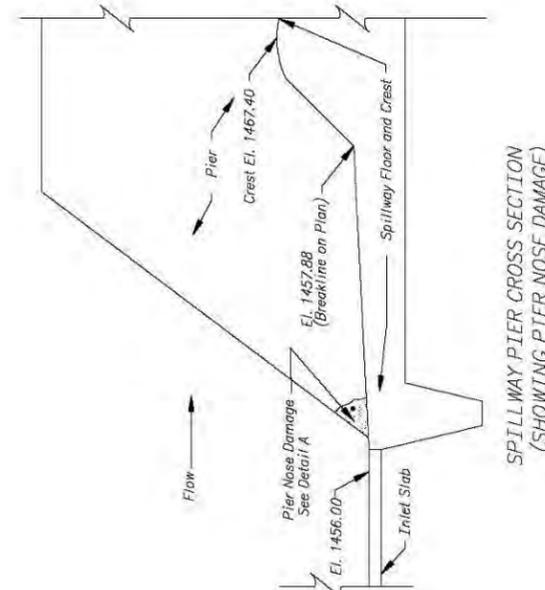
**Figure 1. -  
Early estimate  
of damaged  
concrete.**

The concrete in both the inlet apron and the pier noses/gate structure were exhibiting areas of extensive deterioration. Results of a concrete core testing program [1] showed that the structure was suffering from freeze-thaw damage largely caused by absorptive aggregate. Cracking from freezing and thawing was then promoting alkali-silica reaction. There was also evidence of carbonation which could lead to susceptibility to reinforcement corrosion. Early evaluation of the approach apron of the structure indicated that about 43 percent of the inlet slab area was in need of repair with deterioration measured as deep as 14-inches during the concrete coring program [2]. A plan view (Figure 3) shows which areas were originally thought to be sound concrete and rough estimates of the depth of deterioration in the areas of damaged concrete. However, once repairs were started, the amount of damaged concrete was discovered to be much larger (Figure 4).

**REPAIRS TO PIER NOSES**  
 Average SF per pier = 20  
 # of piers = 11  
 Total Pier Nose Repairs = 220 SF

**REPAIRS TO STRUCTURE**  
 Total Longitudinal = 1,200 sf  
 Total Transverse = 1,500 sf  
 Total Structure Repairs = 2,700 sf

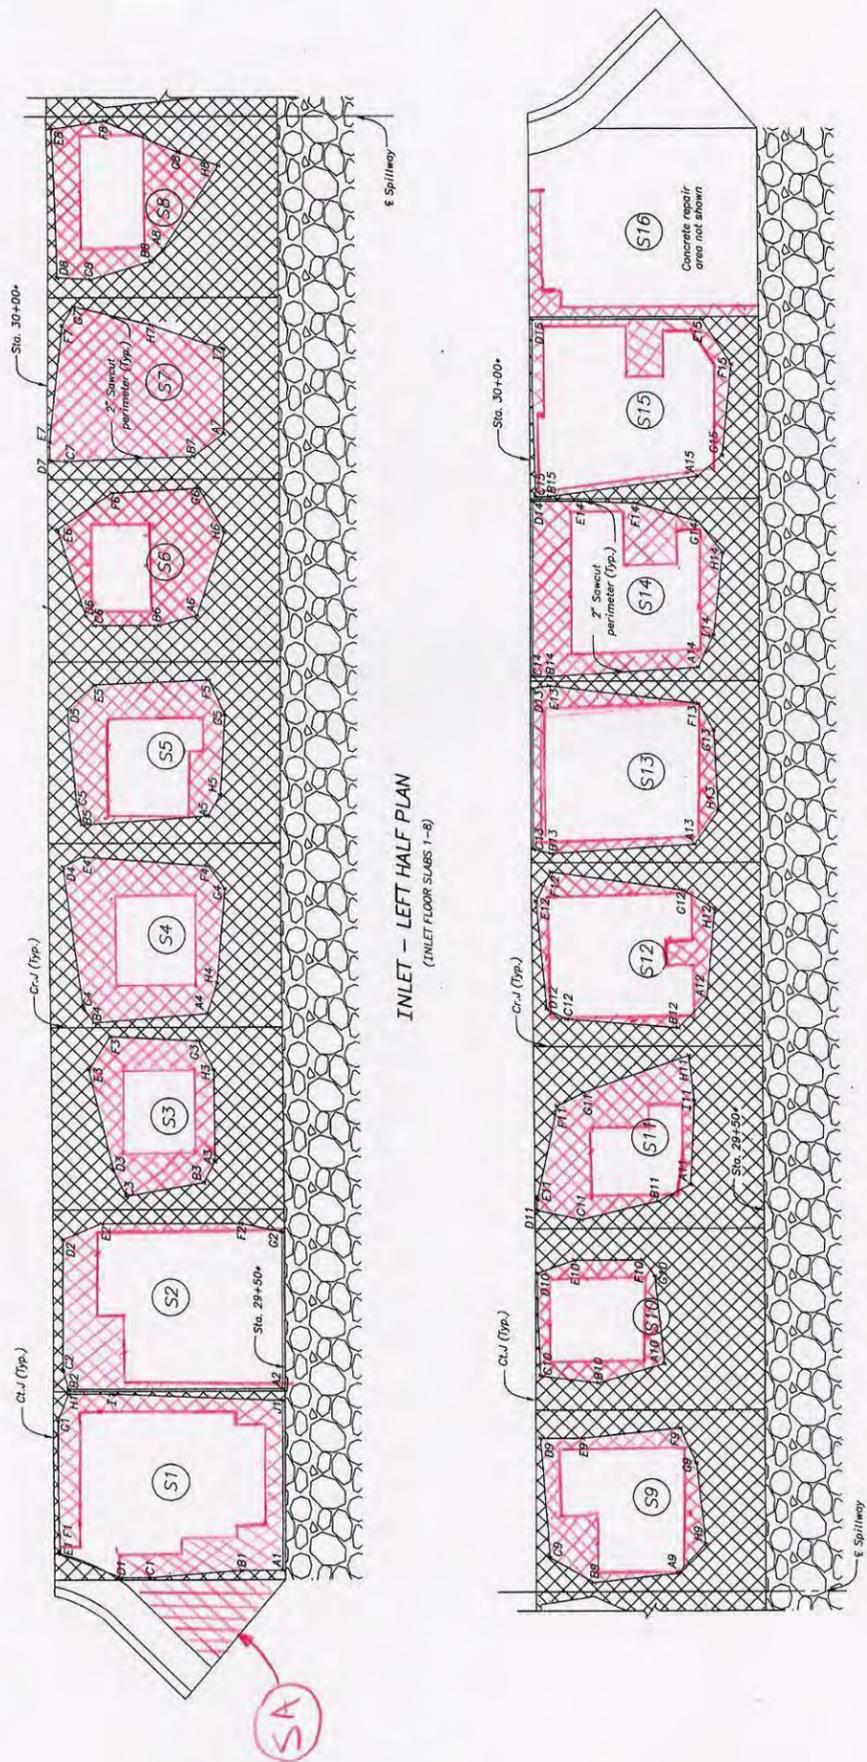
Figure 4. – Revised area of concrete damage.

REPAIR AREAS  
AS MARKED  
ON 9/20/2010.  
REPAIR AREAS  
ARE DRAWN  
APPROXIMATELY  
TO SCALE.

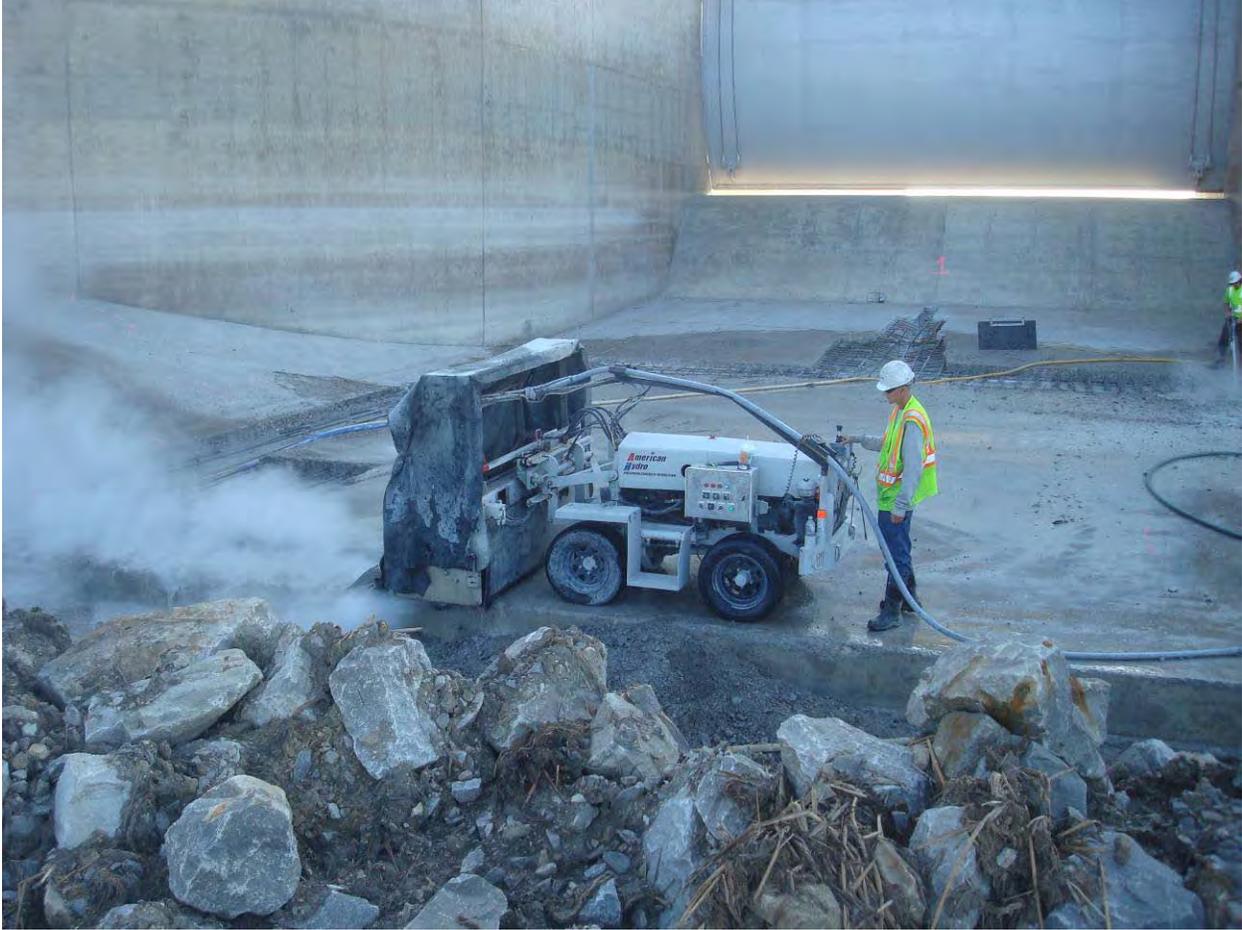
**Figure 5. – Hydrodemolition of damaged concrete**

The repair consisted of removing deteriorated concrete using hydrodemolition (Figure 5) methods and then placing new concrete back to the existing lines and grades. In most areas, damaged concrete was removed to a depth of about 6-inches, leaving about 12-inches of the original concrete. In some areas, due to the poor quality of the concrete, it was excavated down

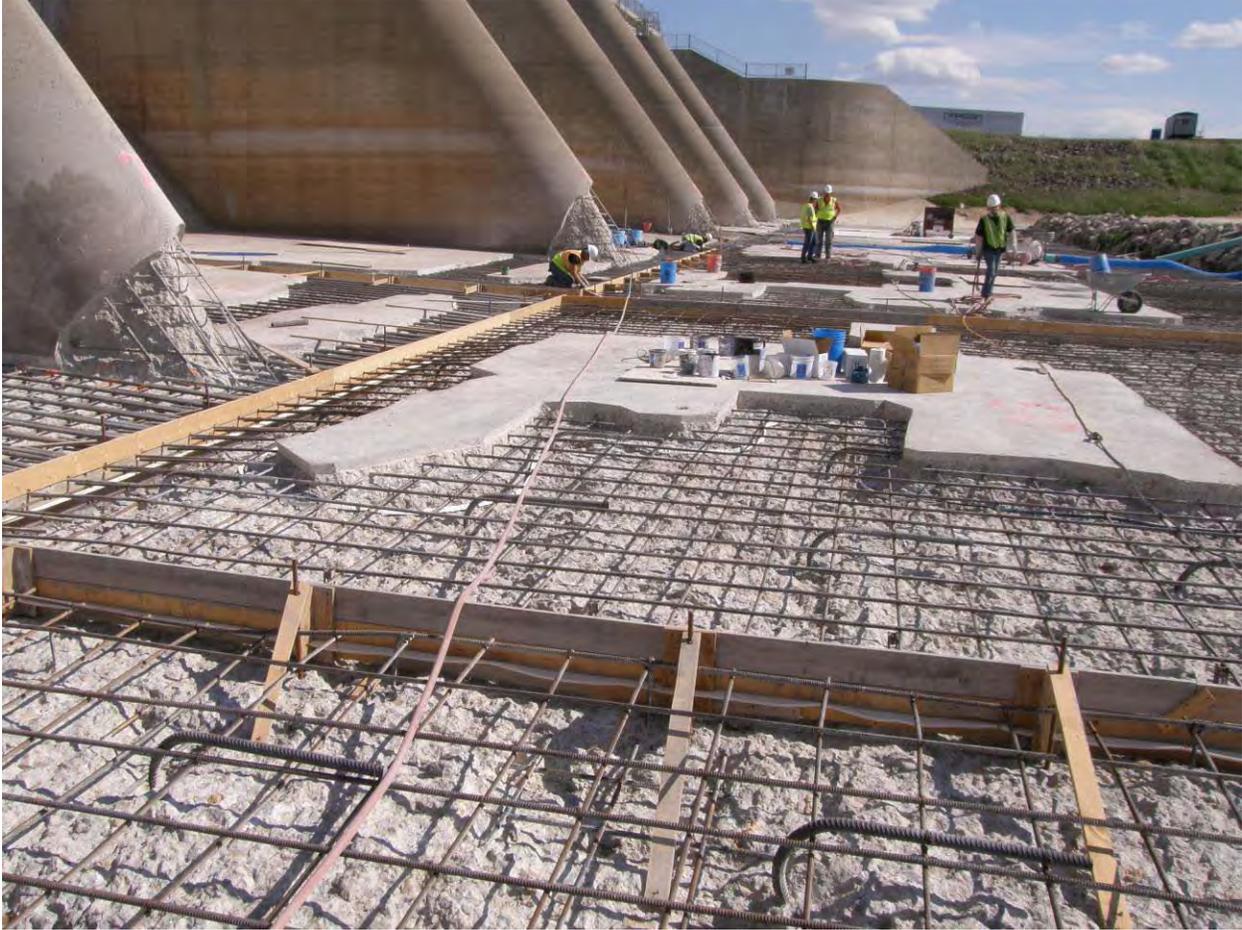
to the foundation. In addition, for some areas, no concrete was removed, so full depth areas of existing concrete were left in place (Figure 6).

**Figure 6. – Example of concrete removal with some original concrete remaining.**

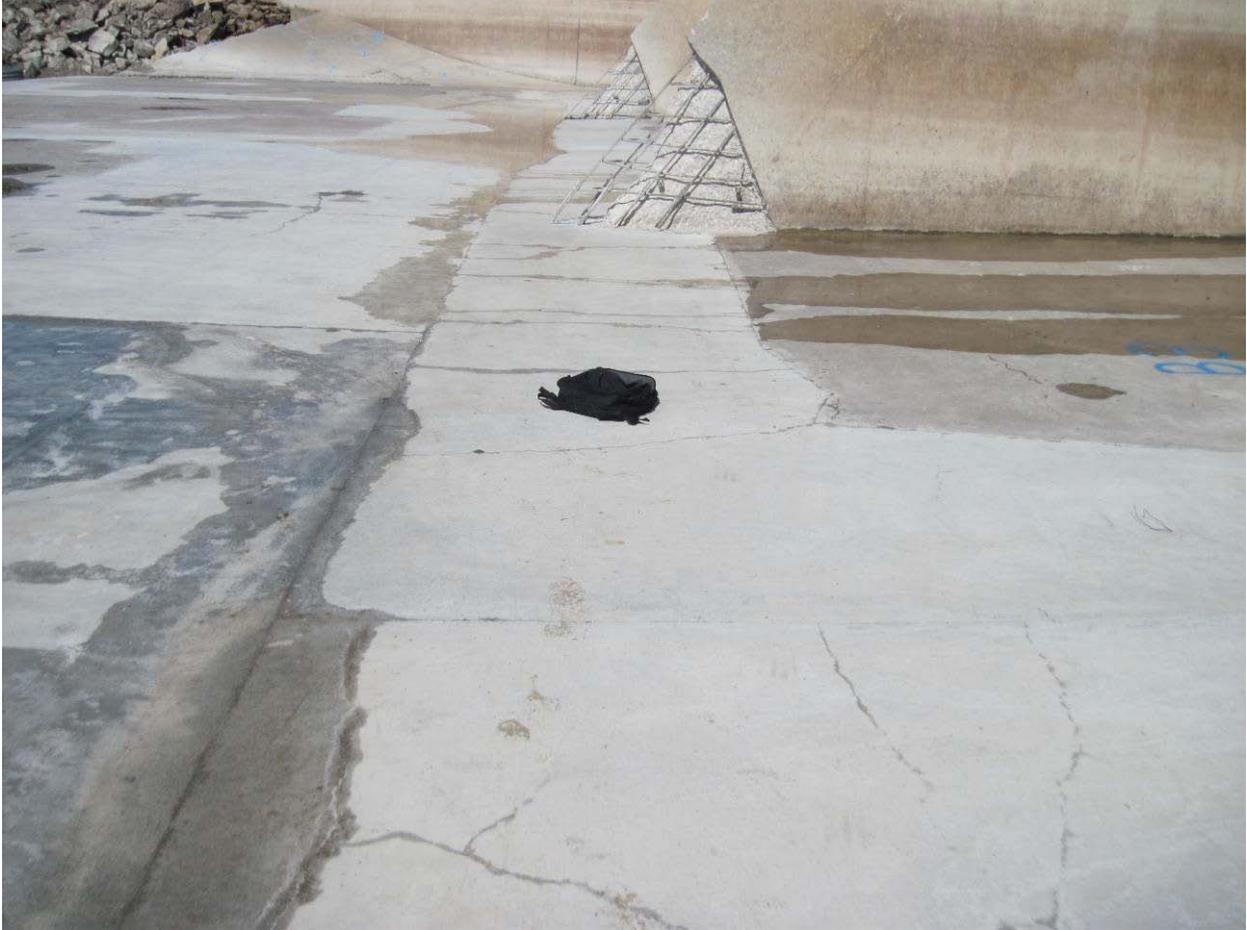
Using smaller aggregate usually increases the paste content of the concrete, which can exacerbate shrinkage problems. The smaller aggregate size used by batch plants in this area of Kansas is typical, since sources with larger aggregate are not readily available. Obtaining larger aggregate to use for the replacement concrete was deemed too costly and restrictive.

After initial placements were performed in the late summer and fall of 2010, restrained shrinkage cracking was observed in the new concrete (Figure 7). The occurrence of this cracking was not unanticipated, but the number and size was disconcerting.

**Figure 7. – View of shrinkage cracking first observed within one to two weeks of concrete placement.**

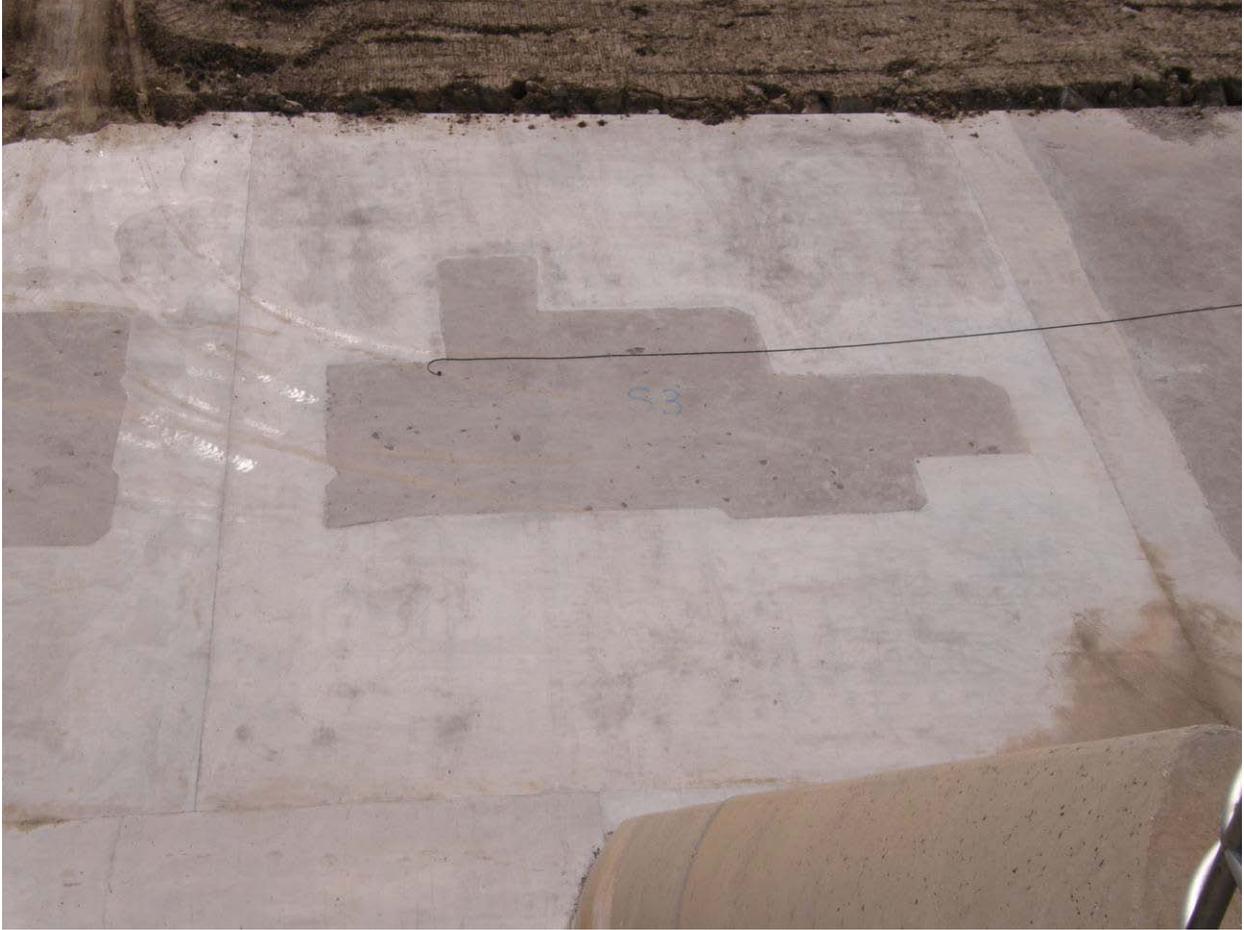
**Figure 10. – Slab 3 placement made with concrete without the Premier Magnesia additive.**

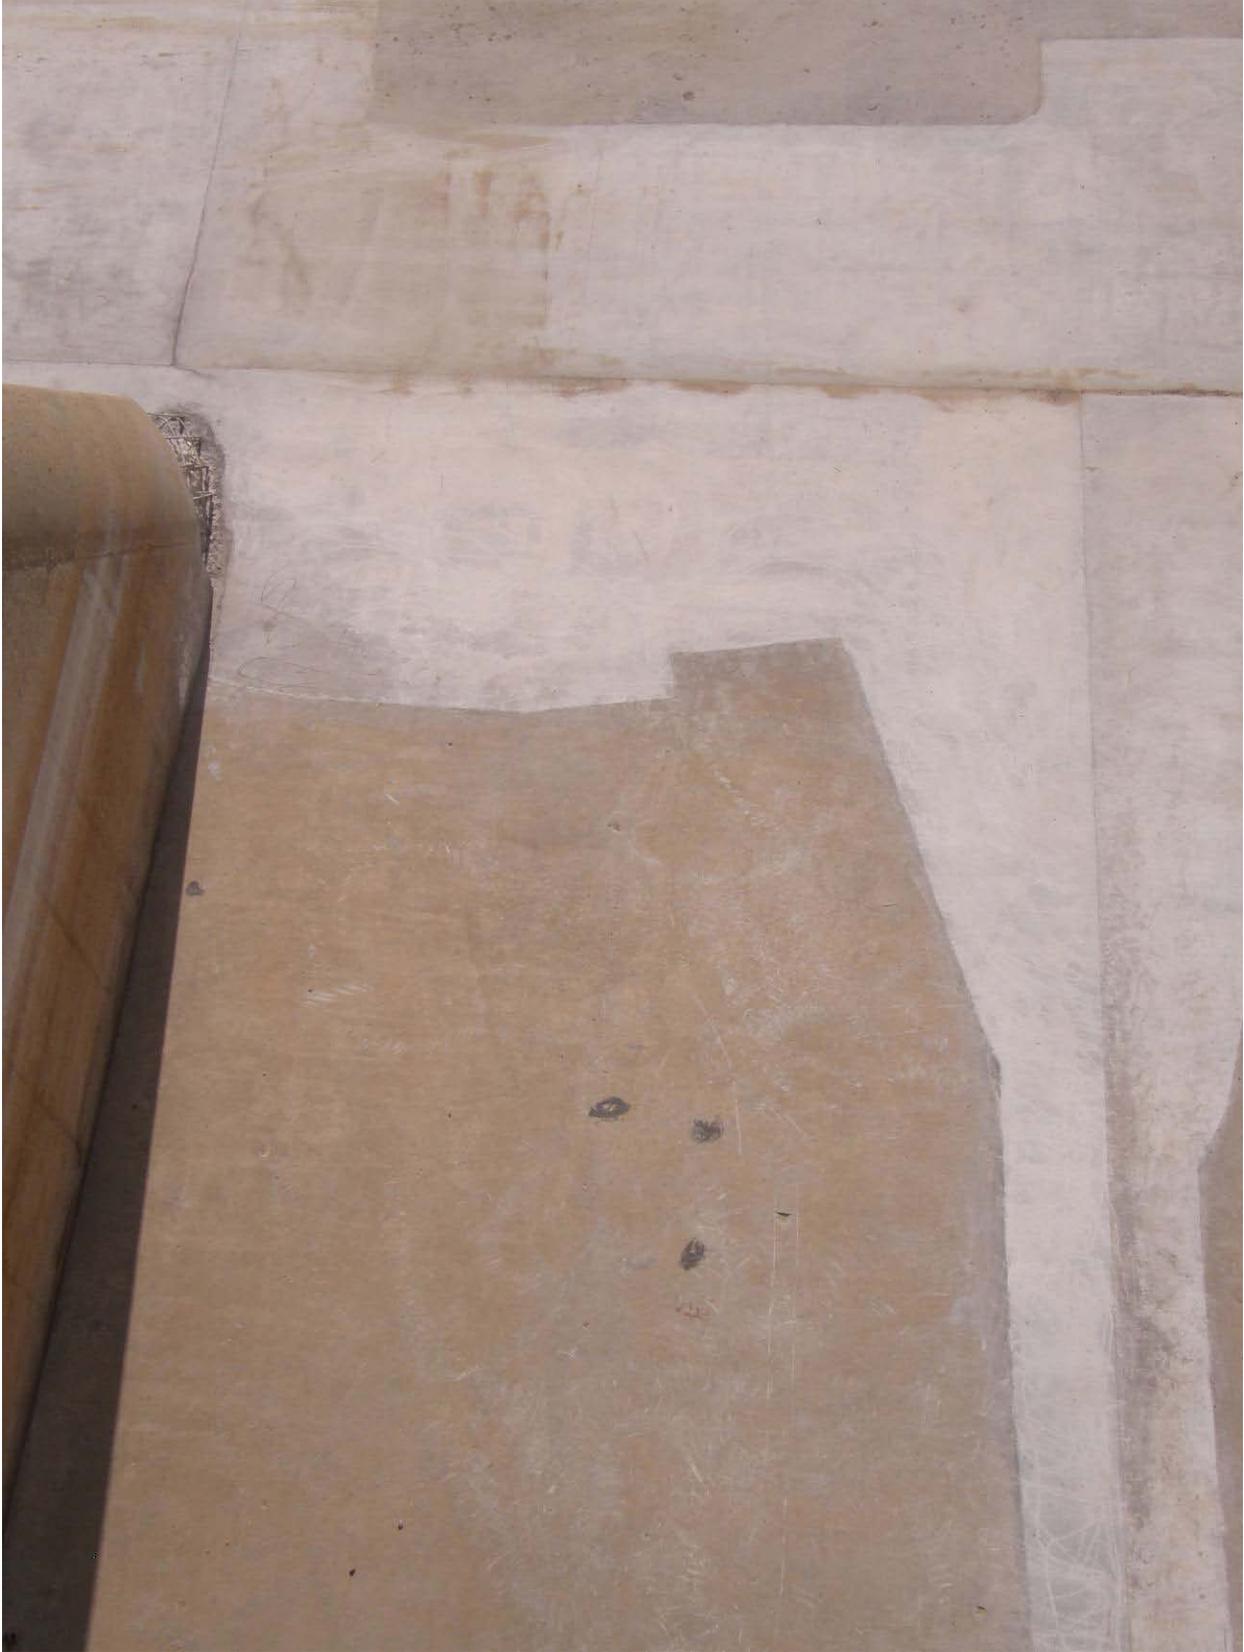
**Figure 11. – Bay 7 placement made with concrete without the Premier Magnesia additive.**

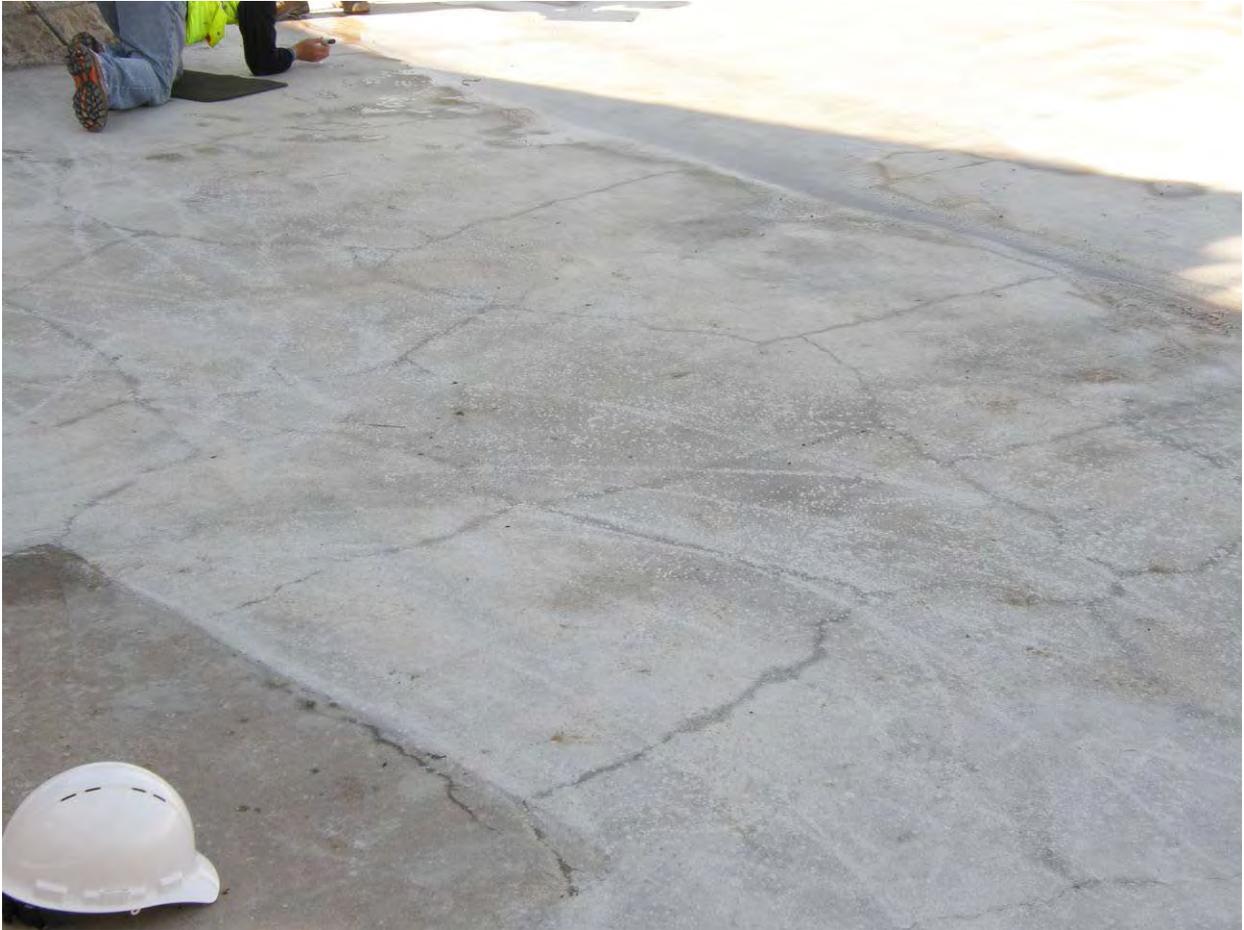
**Figure 13. – Typical shrinkage cracking that was measured and mapped.**

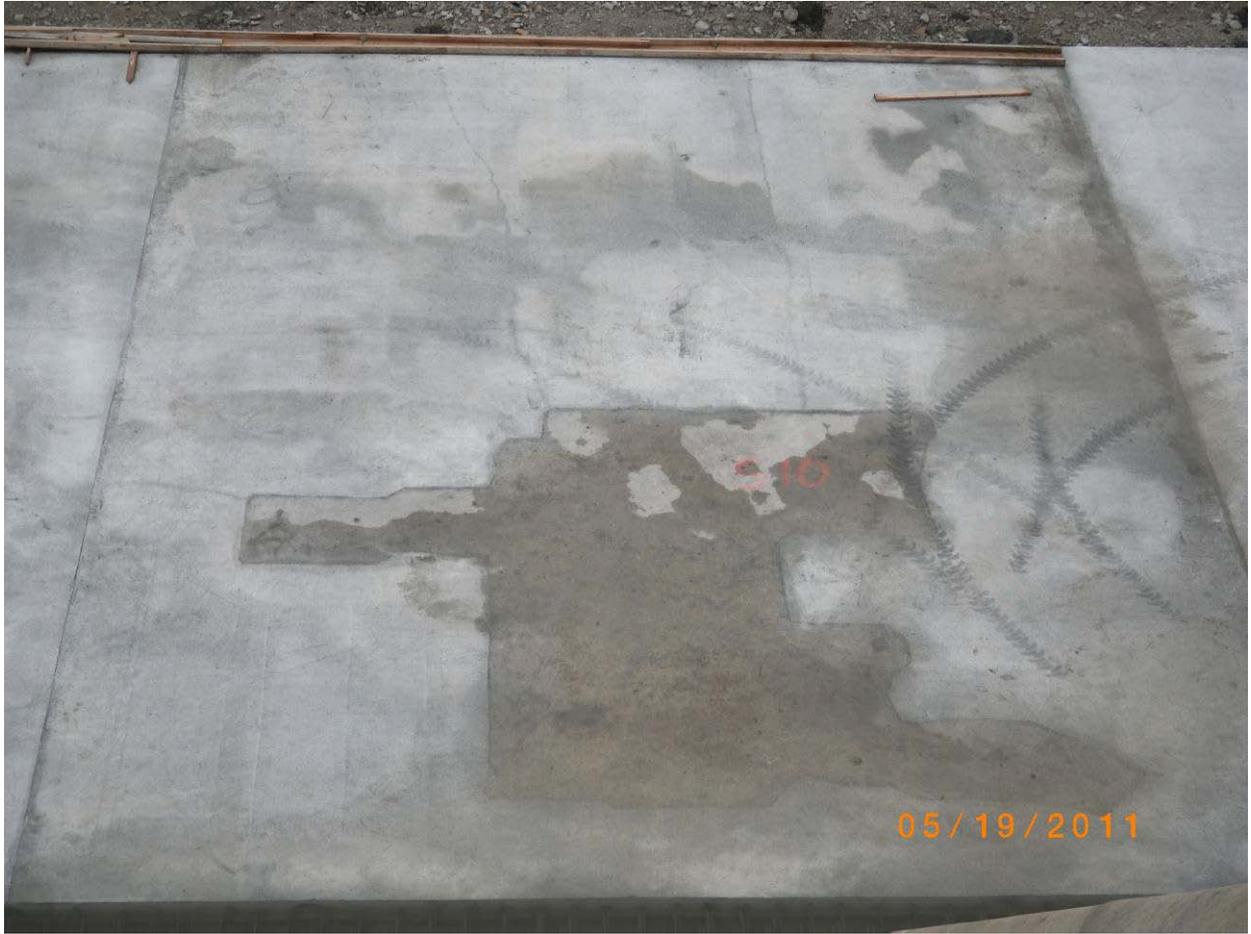
Three weeks later, personnel from MERL and executives from Premier returned to the site to examine the trial concrete placements. Only the placement for slab 10 (S10) showed any cracking (Figure 17), and that was significantly less than cracking observed in the comparison slab. The cracking in S10 was measured and documented in a drawing. The next day, construction activities at the site were halted due to flooding (Figure 18), and as of the middle of August, the area is still underwater.

**Figure 17. – Slab 10 repair made with the trial concrete.**

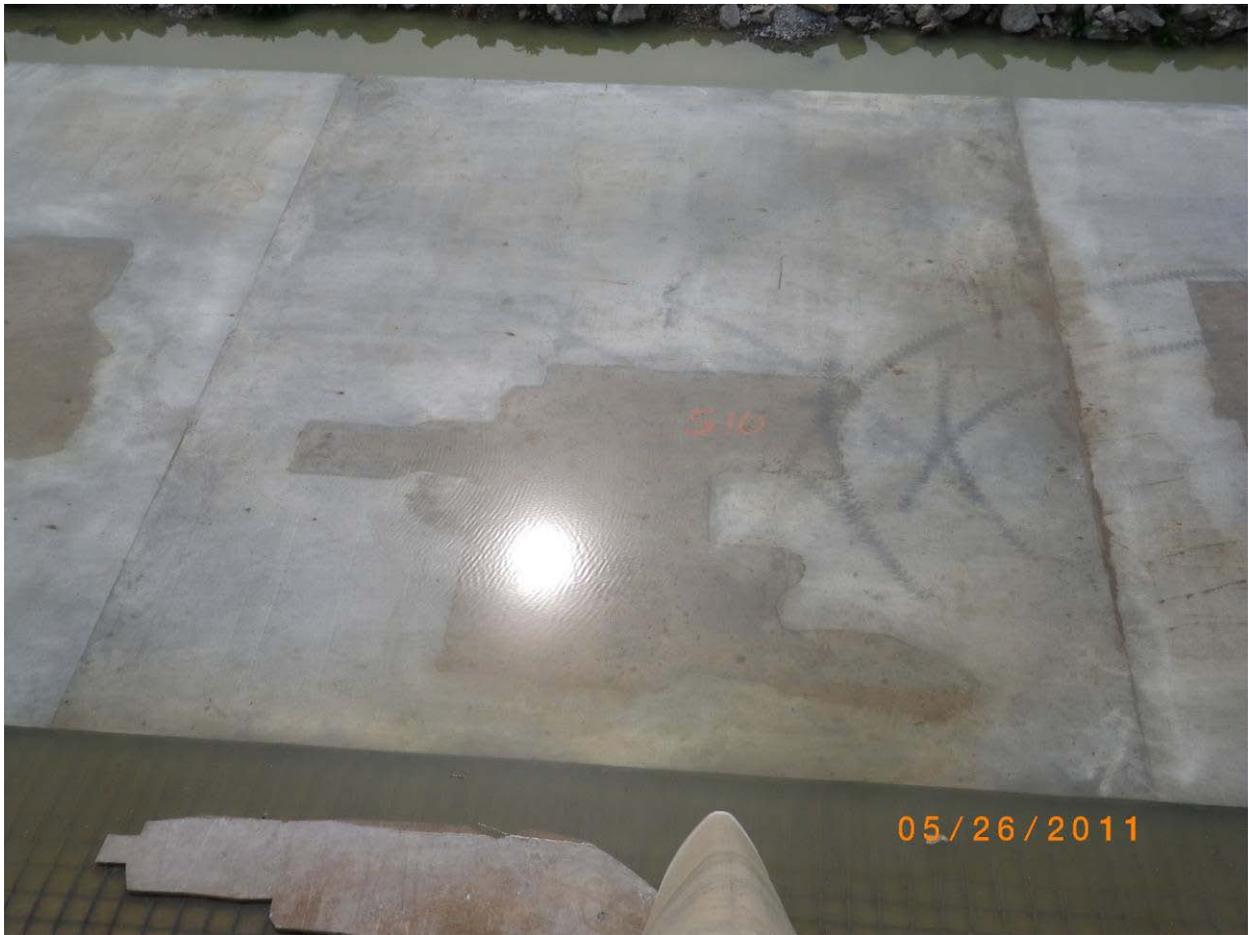
**Figure 18. – Approach apron under water after flooding.**

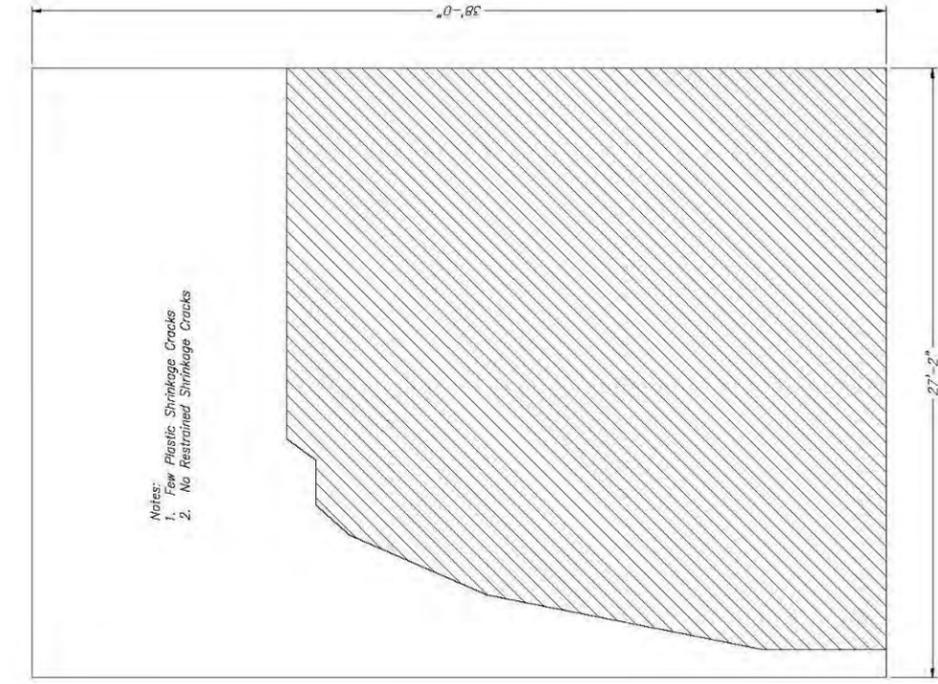
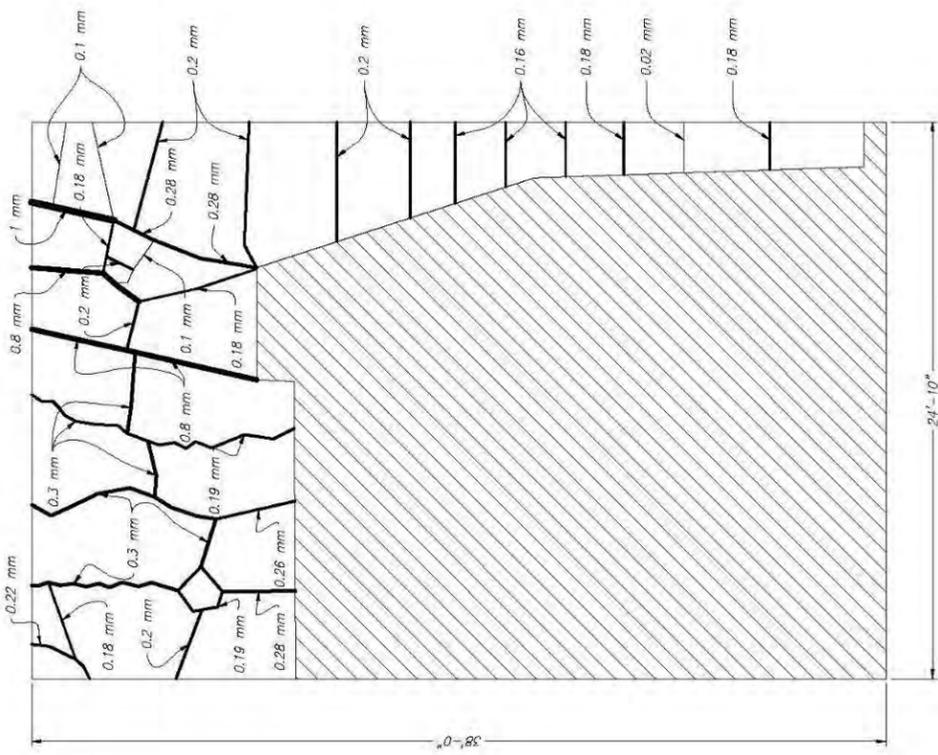
**Figure 19. - Comparison of bay placements made with and without the shrinkage reducing additive.**

Figures 19 and 20 are drawings showing the approximate crack locations and widths of the observed cracks. Since the placement for Bay 8/9 was not in the original plan, a comparable placement from last year was not evaluated. However, there was no cracking observed in that placement. Results show that cracking was either greatly reduced or completely eliminated when cracking was compared between concrete with and without the additive. In addition, surface areas of open cracks were estimated from crack length and opening data. Table 2 shows those comparisons.
