Memorandum Number MERL 2011-34

## **Evaluation of New Concrete Shrinkage Reducing Additive for Glen Elder Dam Spillway Inlet Slab Repair**

**Missouri River Basin Project –  
Solomon Division – Glen Elder Unit - Kansas  
Great Plains Region**

August 2011

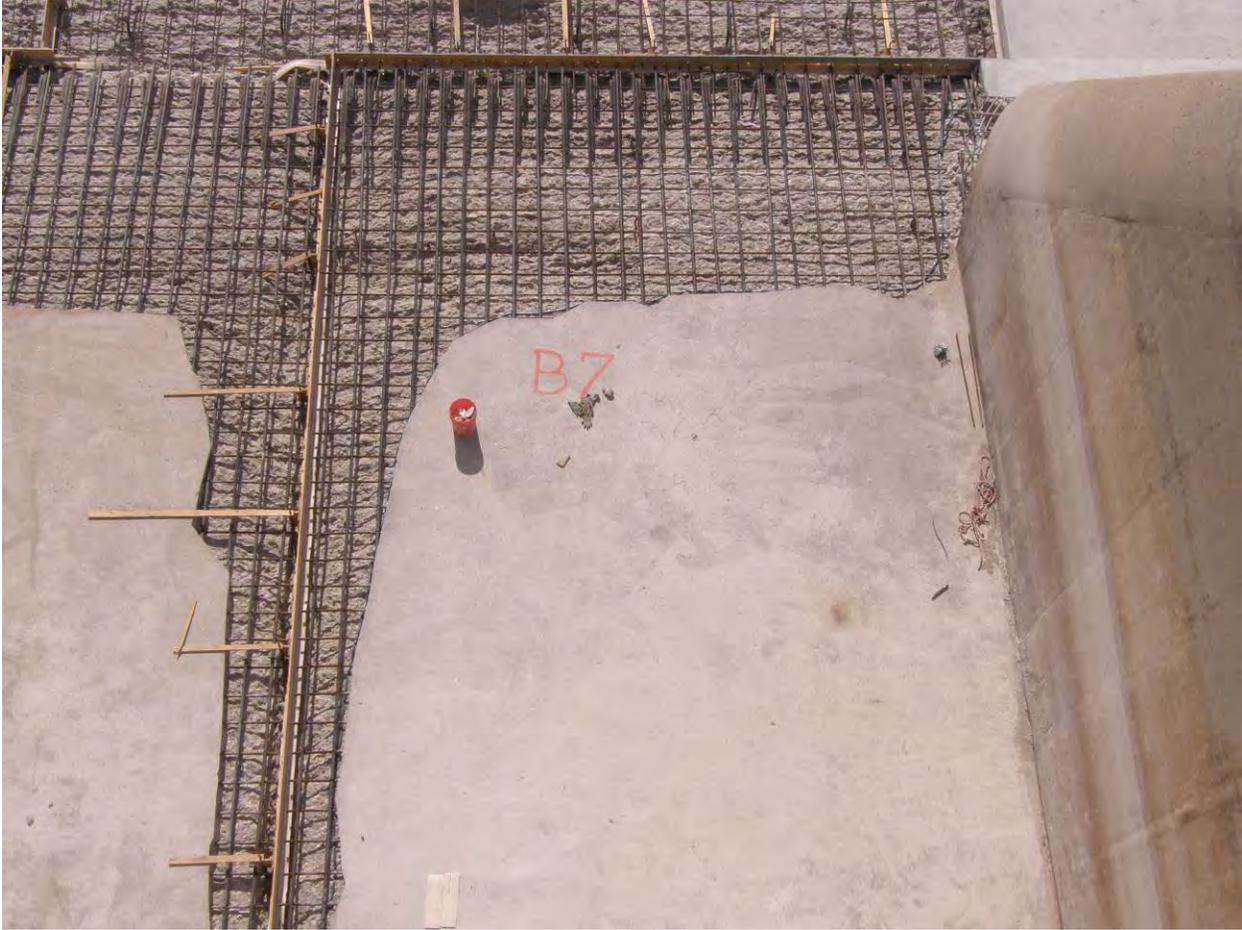
The trial placements occurred in early May. Initially, 2 areas were approved for trials with the Premier additive – one bay area placement (B7, Figure 8) and one approach slab placement (S10,

**Figure 8. Bay 7 ready for trial concrete placement using concrete containing the Premier Magnesia additive.**

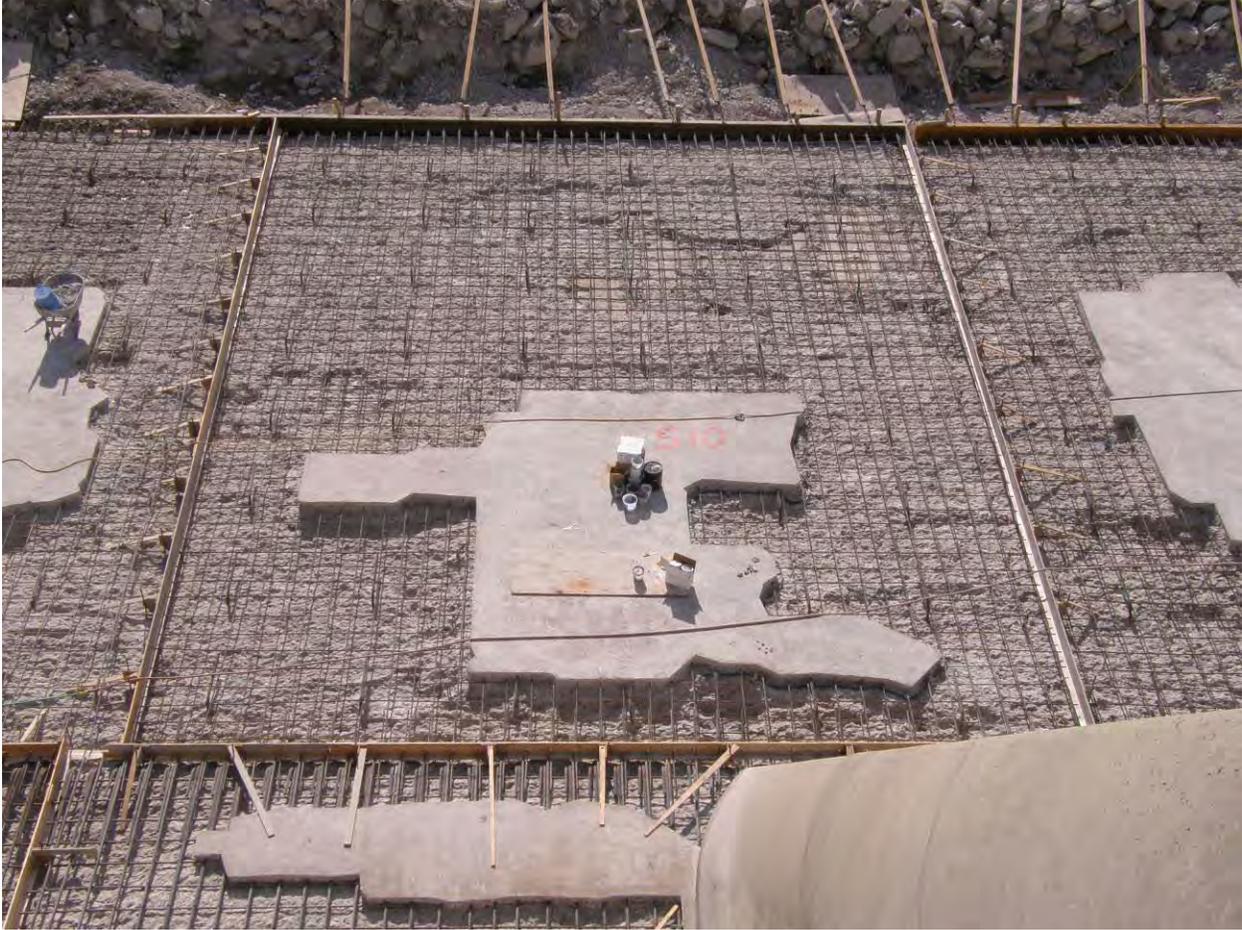
Figure 9). For the comparison crack mapping, two similar areas with about the same shape were selected to map cracks (B3, Figure 10 and S3 Figure 11). One bay area placement (B8 and 9, Figures 12, shown after concrete placement) was added to the trial since material was available and the contractor had time to place additional concrete.

**Figure 9. – Slab 10 ready for trial concrete placement using concrete containing the Premier Magnesia additive.**

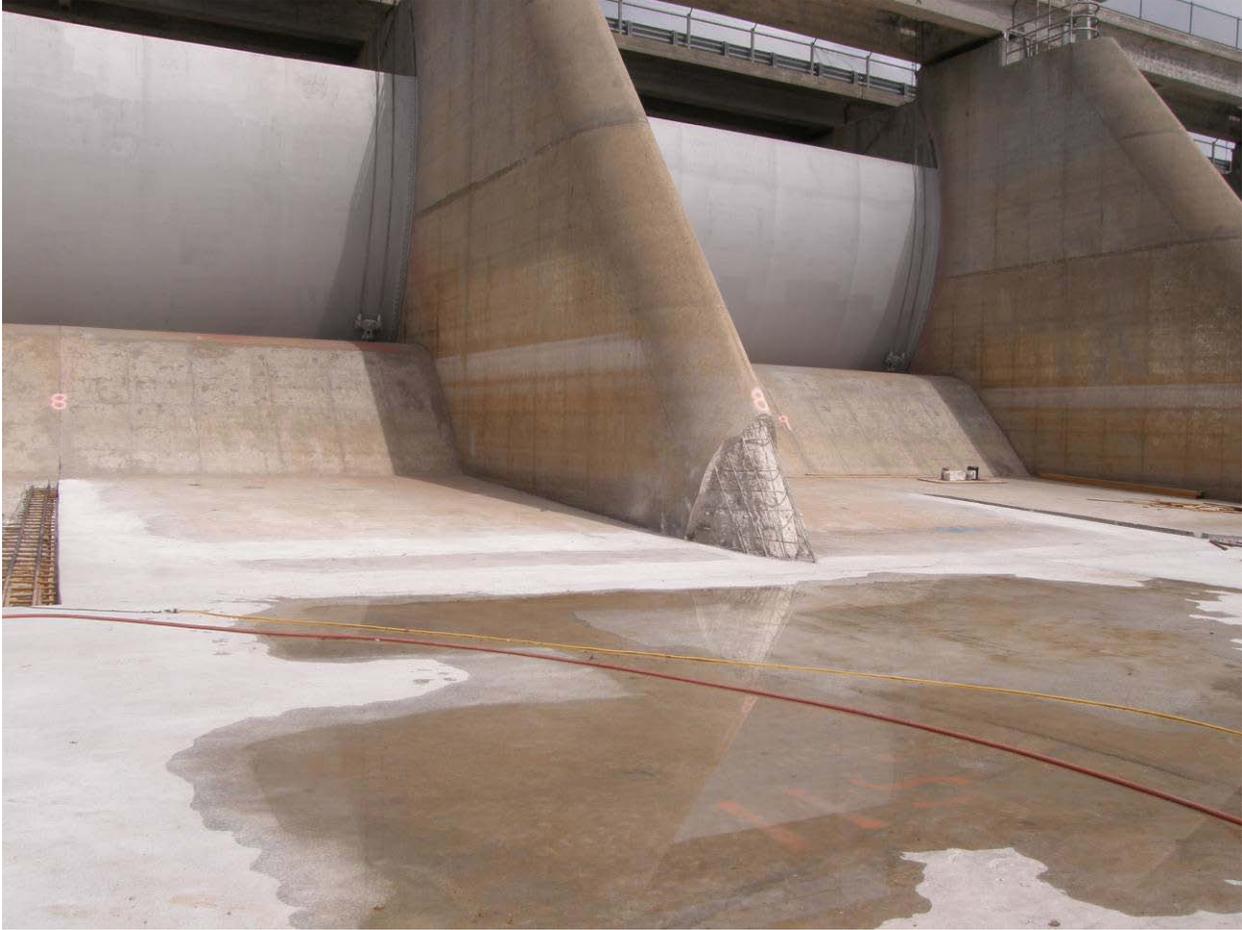
**Figure 12. – Placement B8/9 made with concrete containing the Premier Magnesia additive.**

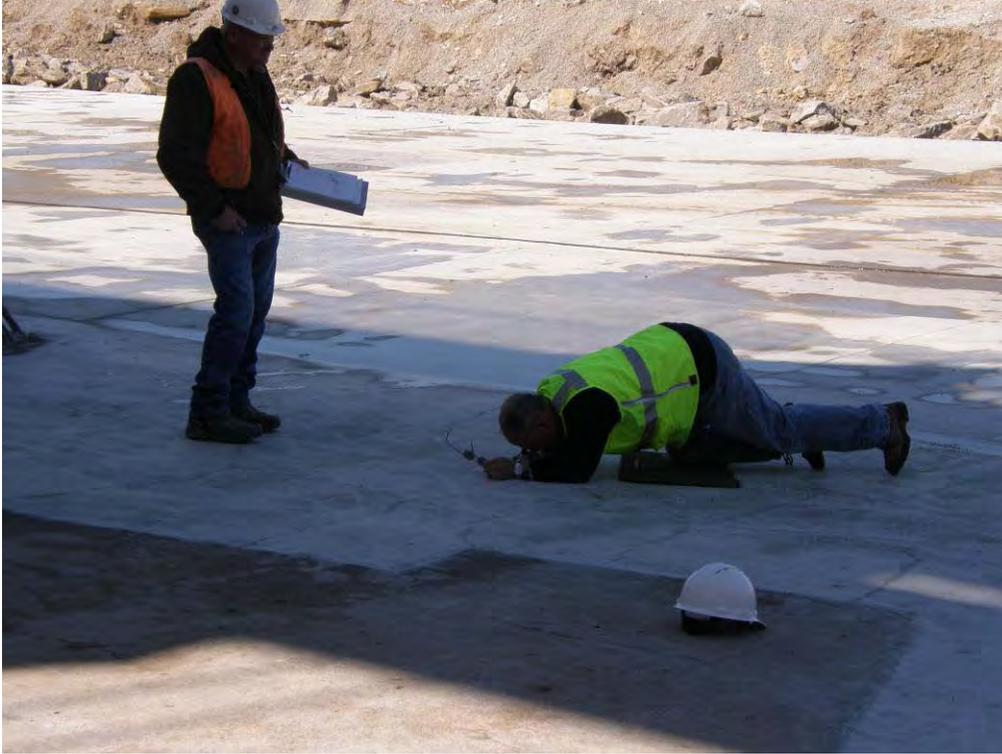
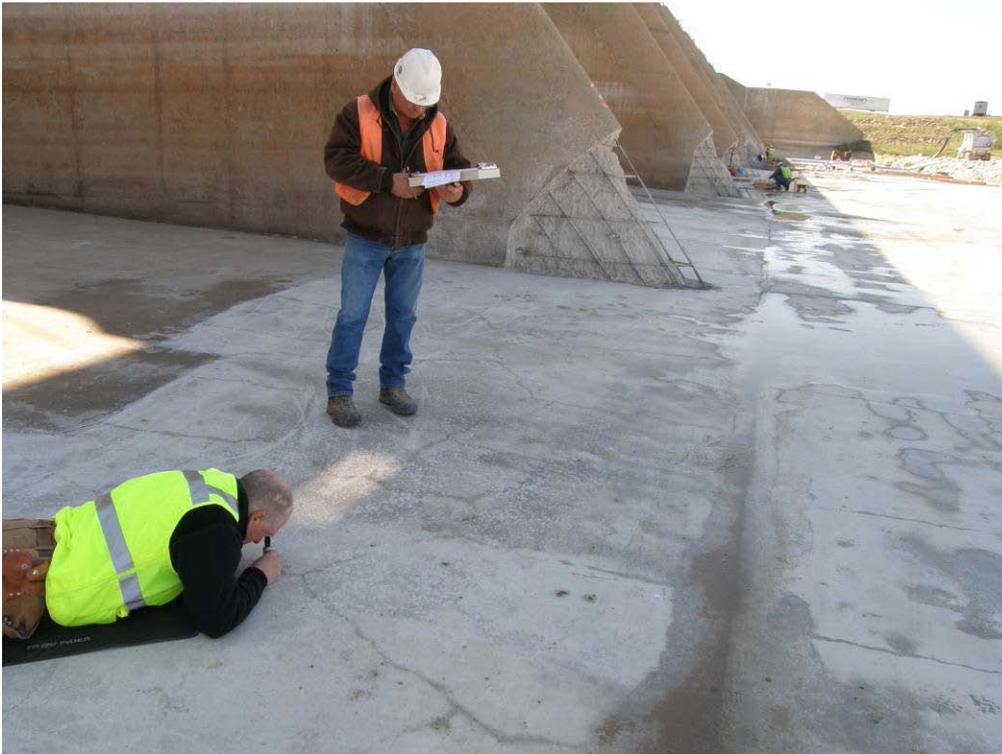
MERL personnel traveled to the site just prior to the placements to map cracks from comparable placements made the fall before (Figures 13 and 14).

**Figure 14. – Measuring crack openings.**

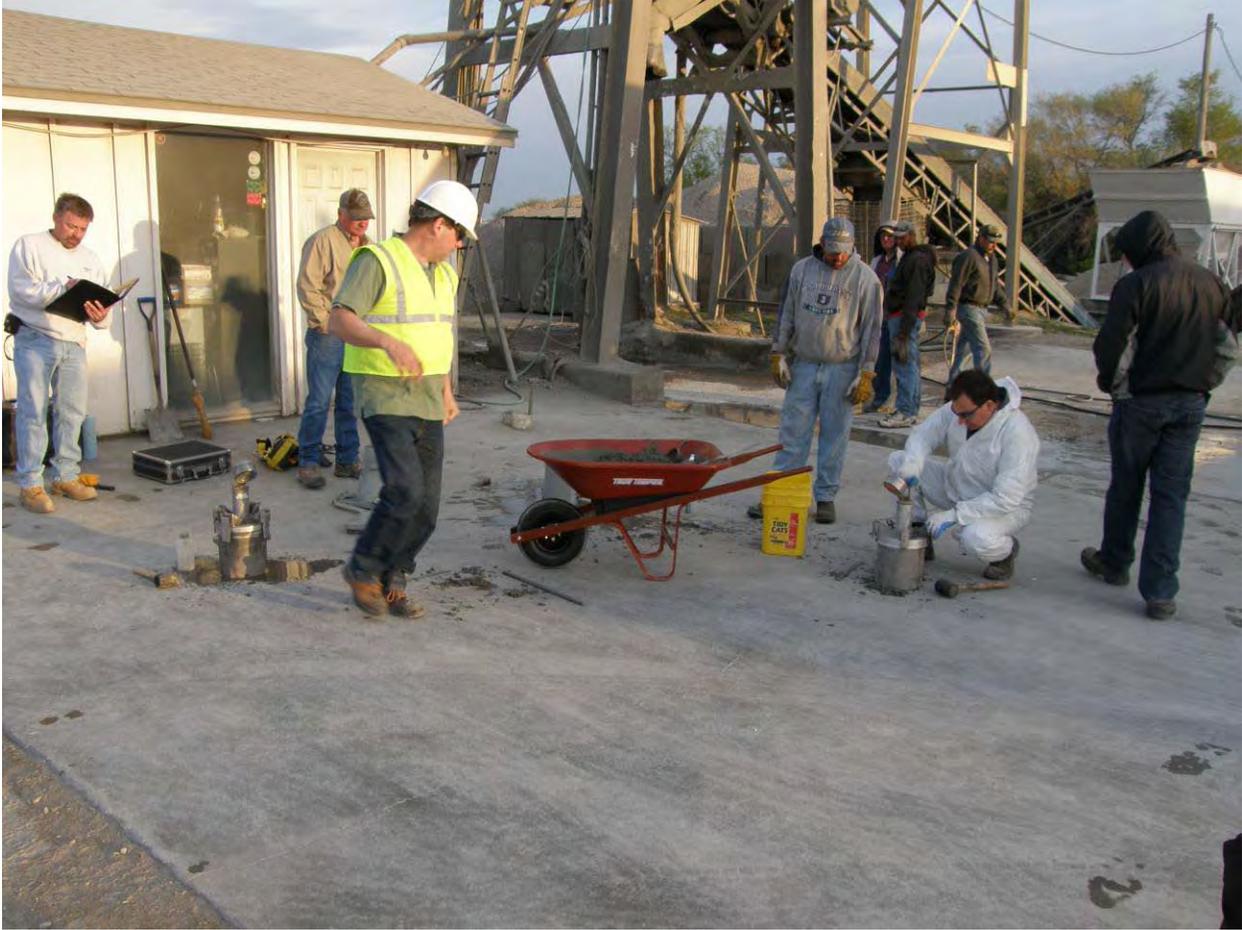
**Figure 15. – Measuring fresh properties of the concrete after addition of the Premier Magnesia additive.**

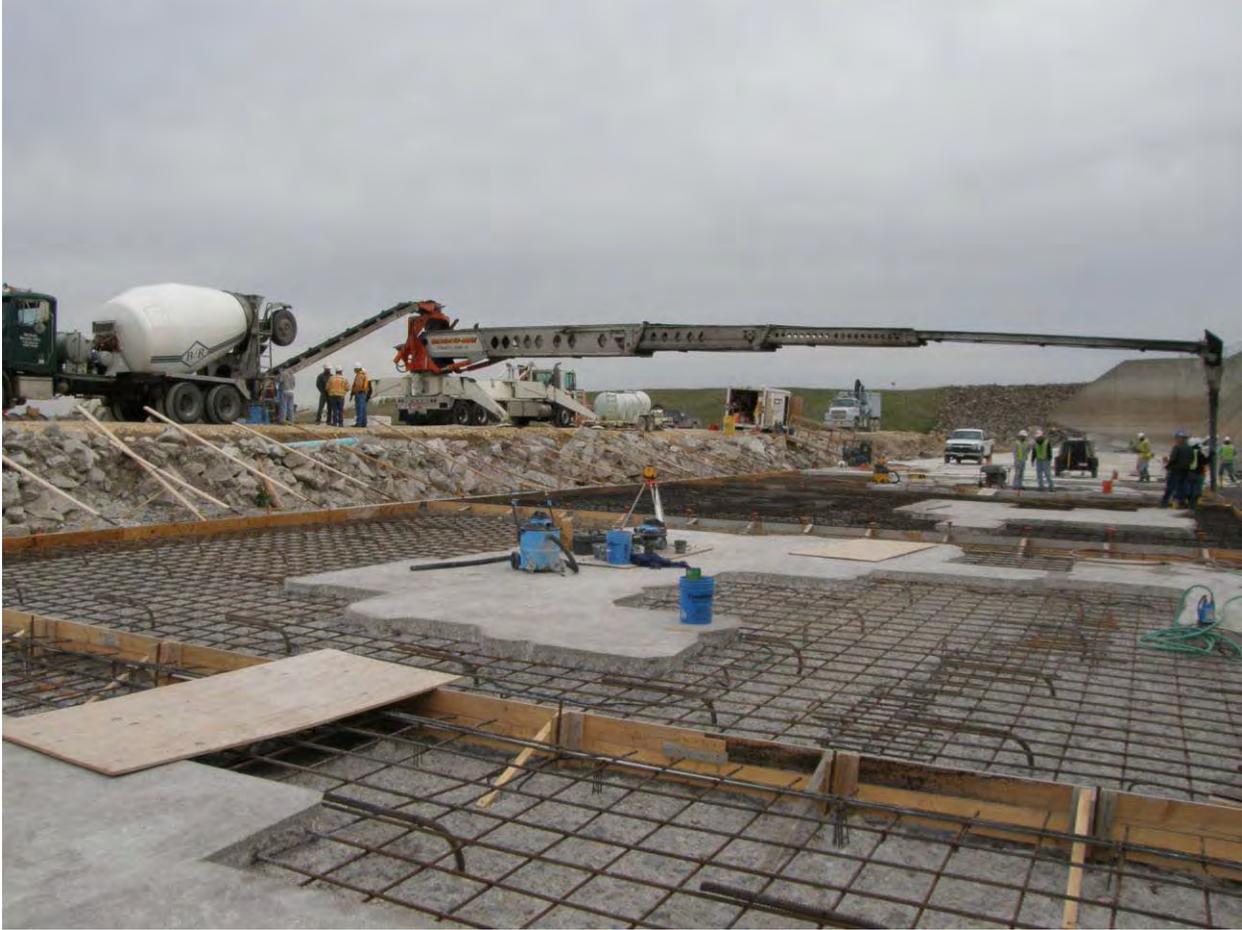
The Premier product was manually added to the mixture by personnel from their lab. Each truck was loaded with about half the concrete batch, then the Premier products, comprised of a liquid component and a dry powder, were added by hand. The rest of the concrete ingredients were added to the truck, it was brought to mixing speed for the appropriate time, and fresh properties were measured (Figure 15). After that, trucks drove to the site, fresh properties were measured again, any adjustments were made as appropriate, and then the concrete was placed using a conveyor system (Figure 16).

**Figure 16. – Placement of the trial concrete.**
